**Flood Control Project Maintenance
Levee Inspections**

Maintenance Issue Types Only, Levee Inspection Report By Mile - Spring 2016

Reclamation District No. 1600 Mull

Waterway	Bank	Unit Miles	Inspection Start/End	Inspector
Unit No. 01 Sacramento River	Right	10.46	03/24/2016 03/24/2016	Jai Lor

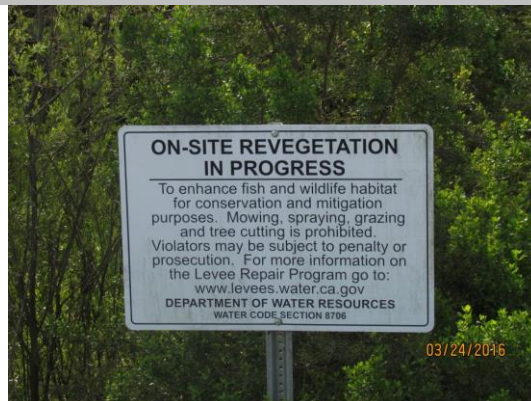
Photo 1 of 2 : SP_2016_RD1600_191_35_20160407_00116.jpg

LM Start	2.35	Rating **	A/W	Issue No.	35
LM End	2.40	Issue Type +	Ma	Location *	WS
Category	Earthen Levee			GPS Latitude/Longitude	
				Start	End
Item	Vegetation			38.704624 °	38.705152 °
				-121.623034 °	-121.622187 °
DWR ID	DWR_RD1600_01_s _ 2012_35				
Comment Code					
V8 : Environmental Requirements.					
Inspector Comment

Sign for revegetation site. Spring 2016.

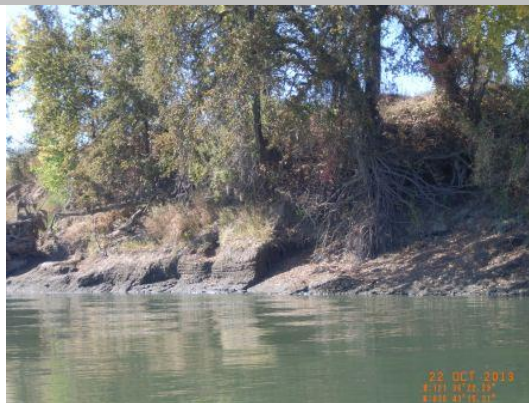
Photo 1 of 1 : SP_2016_RD1600_191_3_20160304_00003.jpg

LM Start	3.58	Rating **	M	Issue No.	3
LM End	3.83	Issue Type +	Ma	Location *	WS
Category	Supplemental			GPS Latitude/Longitude	
				Start	End
Item	2015 USACE Erosion Survey, DRAFT			38.717770 °	38.721351 °
				-121.607423 °	-121.606414 °
DWR ID	DWR_RD1600_01_s_2016_3				
Comment Code					
Inspector Comment					
1997 - Steep high bank. 2005 - Some small pockets in the low toe near the waterline. 2006 - Minor slope clearing. 2010 - Minor new erosion. 2011 - Multiple trees have fallen since last year. Some other trees look ready to fall. Significant new erosion since last year. 2012 - Minor new erosion. 2013 - Minor new erosion. 2015: New minor erosion at toe. [2015 Site ID: SAC_74-4_R]

USACE 2013 Photo #1

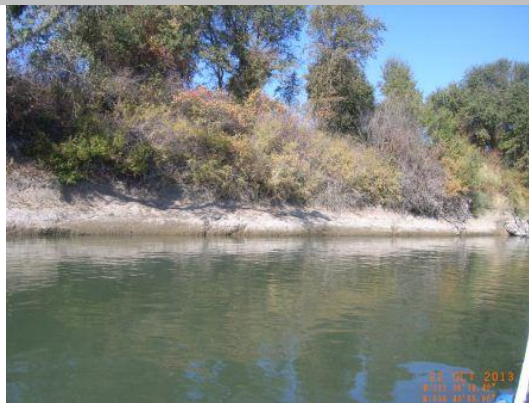
Photo 1 of 1 : SP_2016_RD1600_191_8_20160304_00010.jpg

LM Start	4.34	Rating **	M	Issue No.	8
LM End	4.86	Issue Type +	Ma	Location *	WS
Category	Supplemental			GPS Latitude/Longitude	
				Start	End
Item	2015 USACE Erosion Survey, DRAFT			38.728684 °	38.736110 °
				-121.605844 °	-121.604153 °
DWR ID	DWR_RD1600_01_s_2016_8				
Comment Code					
Inspector Comment					
1997 - Very steep bank. 2005 - Lots of small trees down along the bank at the upstream end. 2006 - Minor new erosion, but slow. 2010 - Almost all of the roots are exposed on the trees, appears ready to fall. 2011 - New erosion and tree popouts. 2012 - Site has become overgrown with vegetation, making it hard to observe. 2015: Dense vegetation made observation difficult. [2015 Site ID: SAC 75-3 R]

USACE 2013 Photo #1

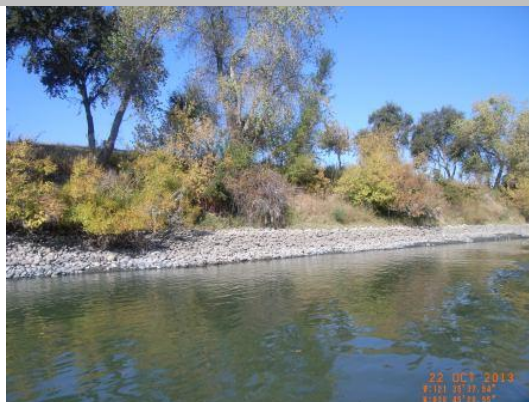
Photo 1 of 1 : SP_2016_RD1600_191_9_20160304_00011.jpg

LM Start	6.30	Rating **	A/W	Issue No.	9
LM End	6.36	Issue Type +	Ma	Location *	WS
Category	Supplemental			GPS Latitude/Longitude	
				Start	End
Item	2015 USACE Erosion Survey, DRAFT			38.755246 °	38.756186 °
				-121.594206 °	-121.594024 °
DWR ID	DWR_RD1600_01_s_2016_9				
Comment Code					
Inspector Comment					
2011 - Large vertical eroded face from a rotational failure just below pump. 2015: Does not meet criterial. [2015 Site ID: SAC_77-0_R]

USACE 2013 Photo #1

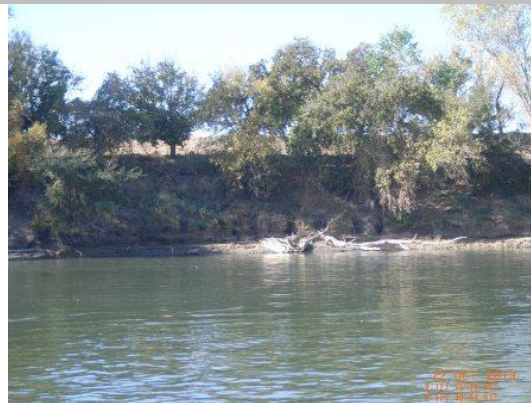
Photo 1 of 1 : SP_2016_RD1600_191_6_20160304_00008.jpg

LM Start	6.95	Rating **	M	Issue No.	6
LM End	6.98	Issue Type +	Ma	Location *	WS
Category	Supplemental			GPS Latitude/Longitude	
				Start	End
Item	2015 USACE Erosion Survey, DRAFT			38.764801 °	38.765219 °
				-121.594926 °	-121.595049 °
DWR ID	DWR_RD1600_01_s_2016_6				
Comment Code					
Inspector Comment					
2006 - Eddy scour off end of rock causing erosion and scour hole near levee. Sandy silt bank with rock on upstream end. 2010 - Trees are leaning more, minor new erosion. 2011 - Many of the tree roots have scoured out and trees look ready to fall. 2015: No observed changes. [2015 Site ID: SAC_77-7_R]

USACE 2013 Photo #1
